## **BEBINGTON HALL PARK**

### **COMMON AREAS**

### **Asbestos Type 2 Survey Report**

**16<sup>th</sup> January 2010**

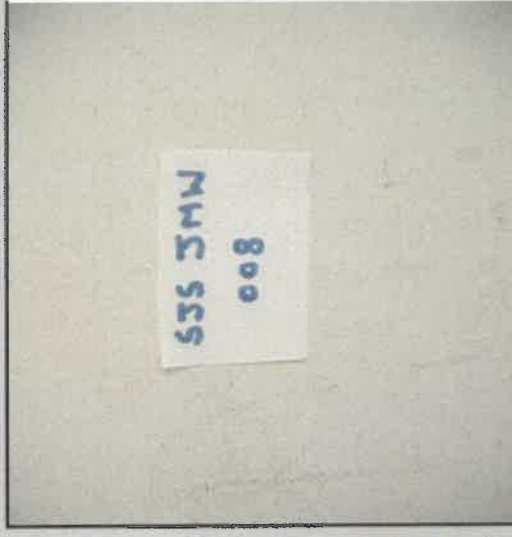
Site Photograph/Plan

Low Damage

Material Assessment Score:

7

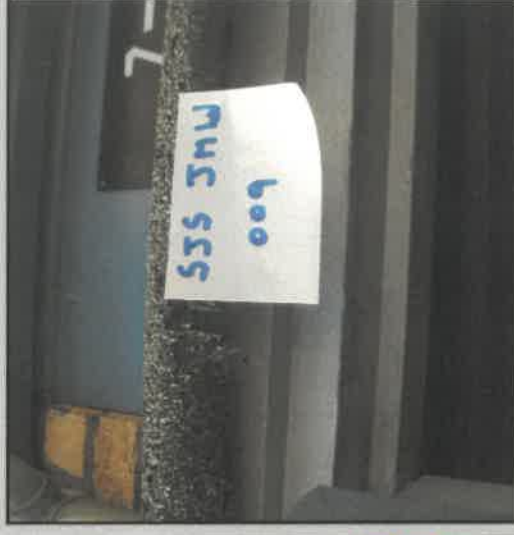
Site Photograph/Plan

Good condition

Material Assessment Score:

1

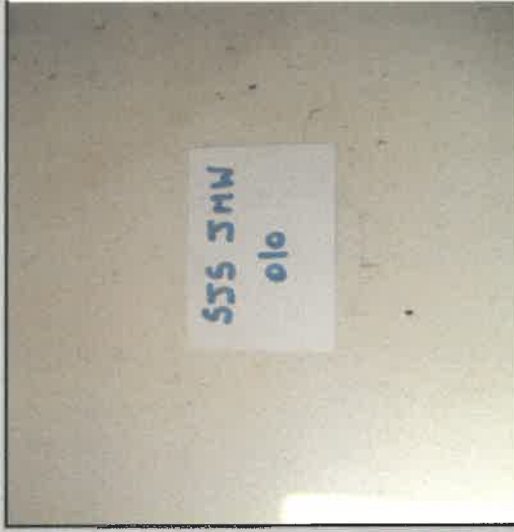
Site Photograph/Plan

Low Damage

Material Assessment Score:

7

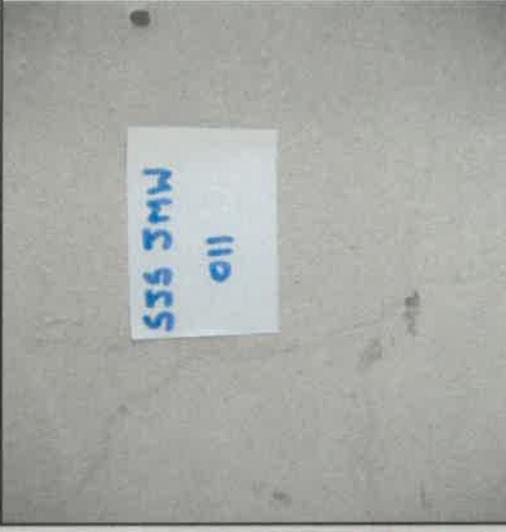
16-21 Kings Close Higher Bebington  
Wirral CH63 5QZ

Low Damage

☒ Asbestos Confirmed  
☐ Asbestos Assumed  
☐ No Asbestos Detected

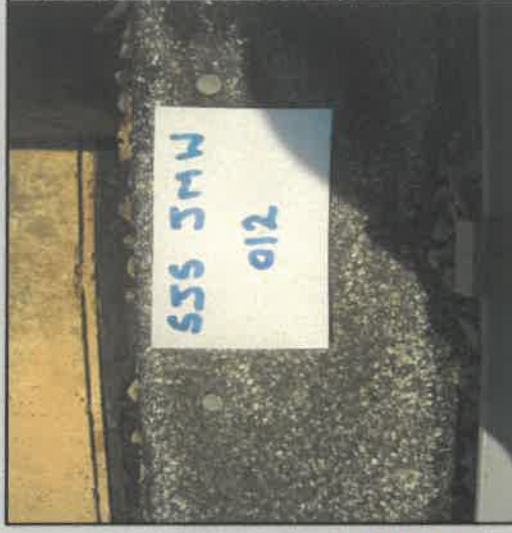
Site Photograph/Plan

| Extent of Damage | Good condition |

| Material Assessment Score: | 1 |

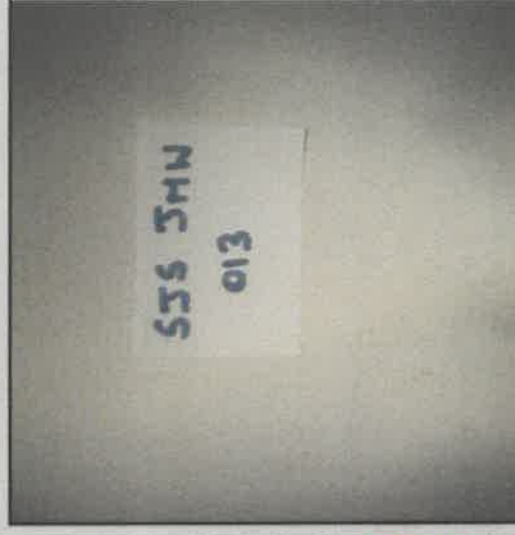
Site Photograph/Plan

Low Damage

Material Assessment Score:

7

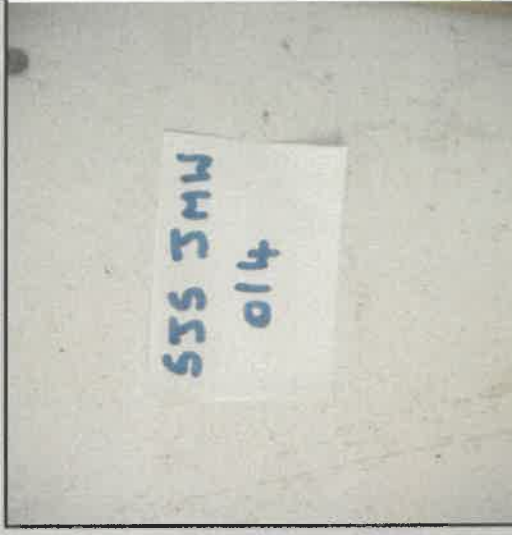
Bebington Hall Park  
22-30 Kings Close Higher Bebington  
Wirral CH63 5QZ

Good condition

☒ Asbestos Confirmed

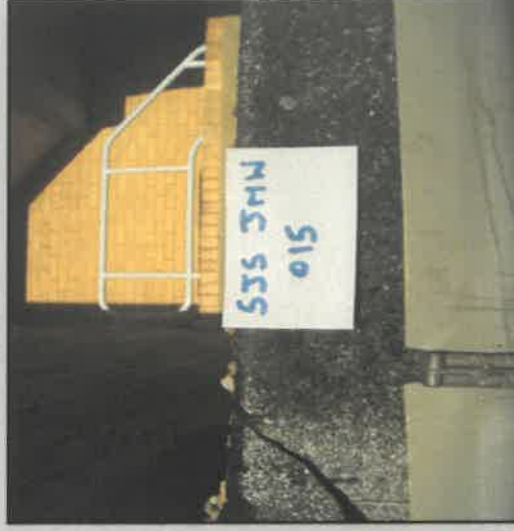
Site Photograph/Plan

Good condition

Material Assessment Score:

1

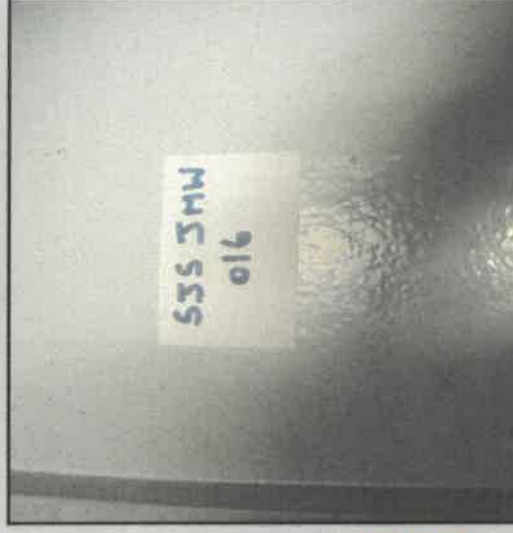
Site Photograph/Plan

Good condition

Amosite (Brown)

Material Assessment Score:

6

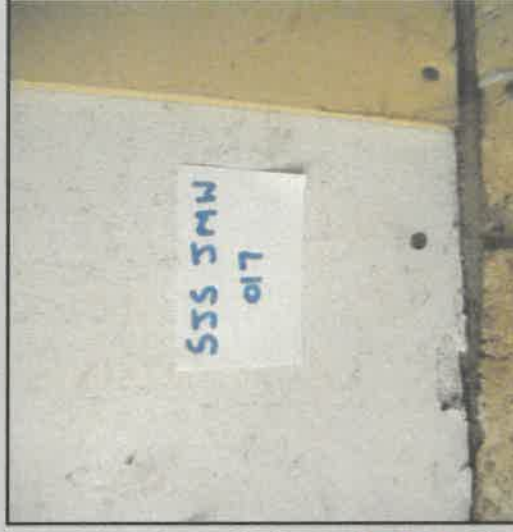
Site Photograph/Plan

Good condition

Amosite (Brown)

Material Assessment Score:

6

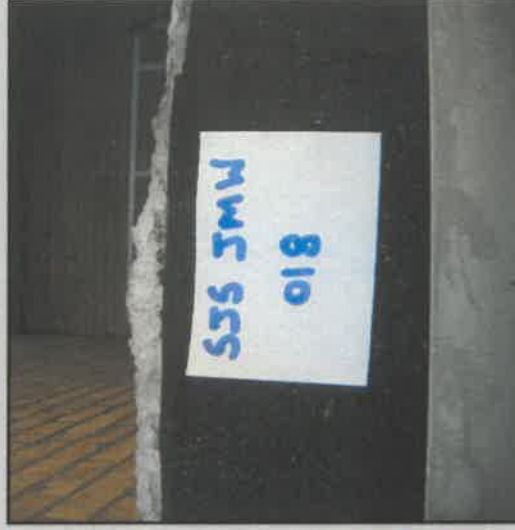
Site Photograph/Plan

Good condition

Material Assessment Score:

1

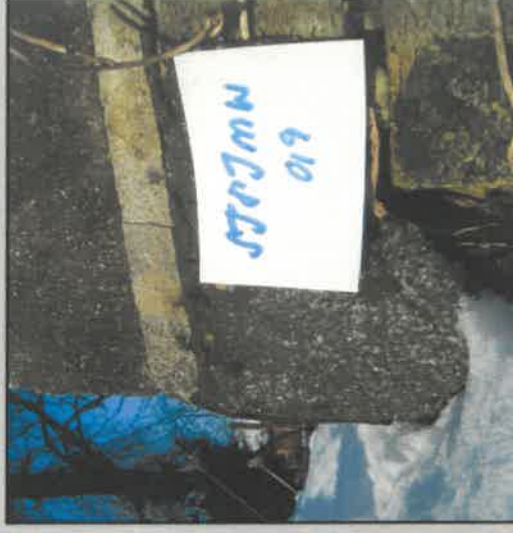
Garage for 6 Mount Way Higher  
Bebington Wirral CH63 5RA

Good condition

Material Assessment Score:

1

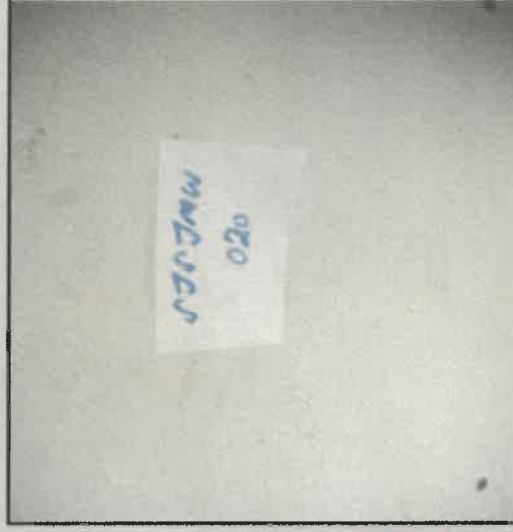
Site Photograph/Plan

Low Damage

Material Assessment Score:

7

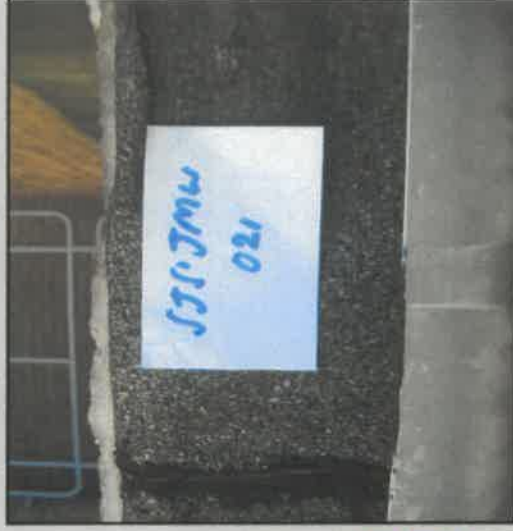
Site Photograph/Plan

Low Damage

Material Assessment Score:

2

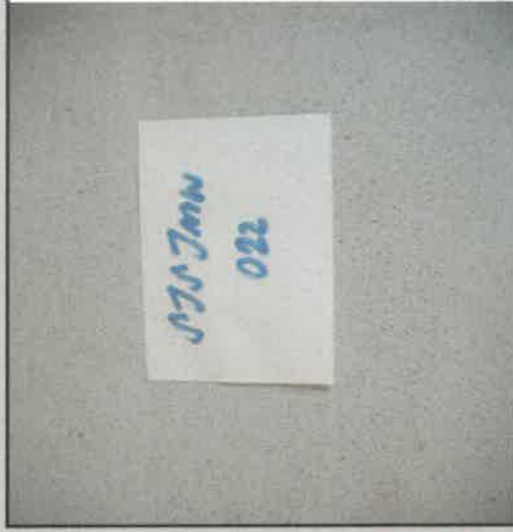
Site Photograph/Plan

Good condition

Material Assessment Score:

6

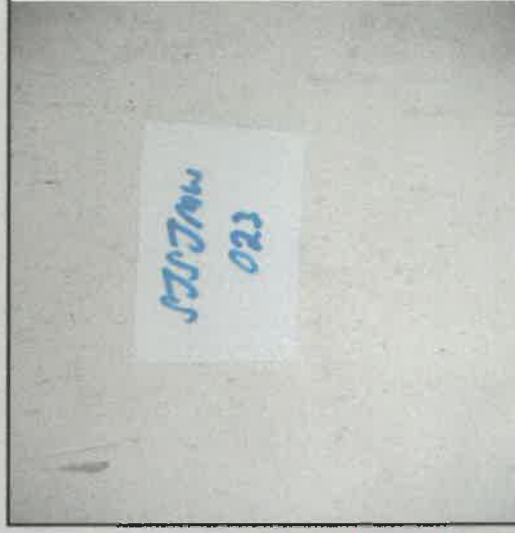
Site Photograph/Plan

Low Damage

Material Assessment Score:

7

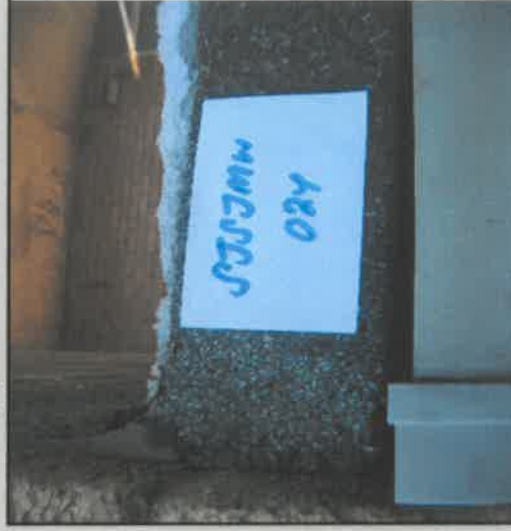
10-18 Mount Way Higher Bebington  
Wirral CH63 5RA

Good condition

Material Assessment Score:

1

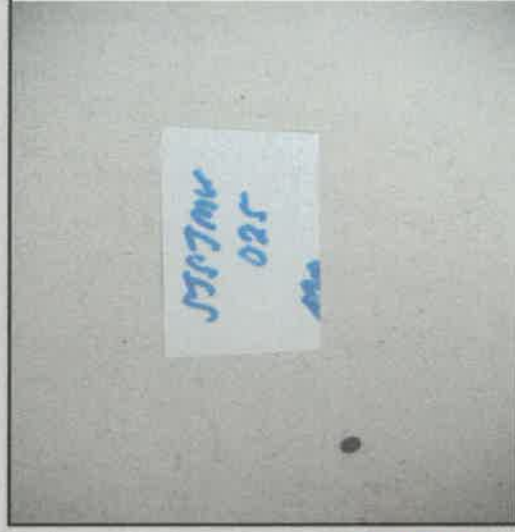
Site Photograph/Plan

Low Damage

Material Assessment Score:

7

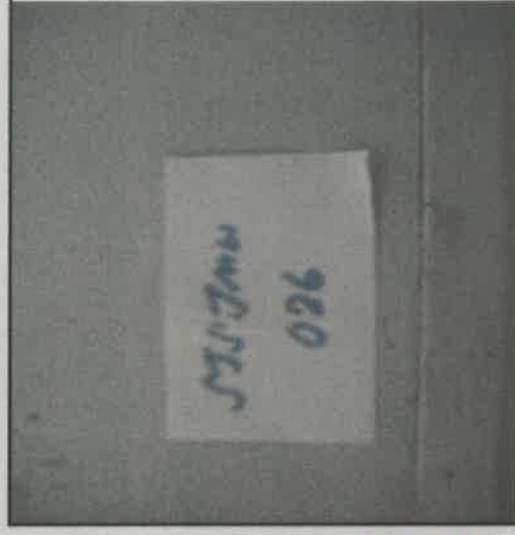
Site Photograph/Plan

Low Damage

Material Assessment Score:

7

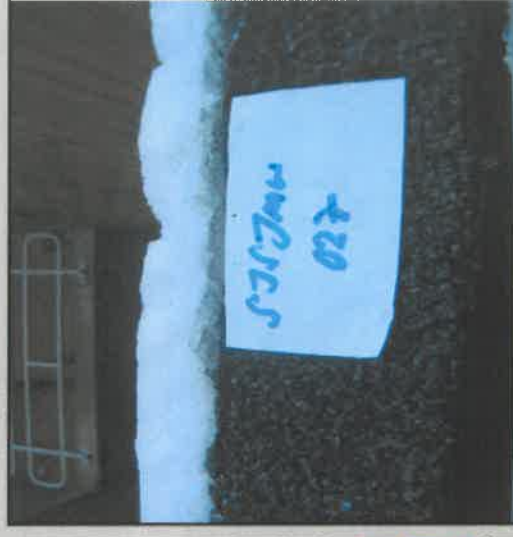
Site Photograph/Plan

Good condition

Material Assessment Score:

1

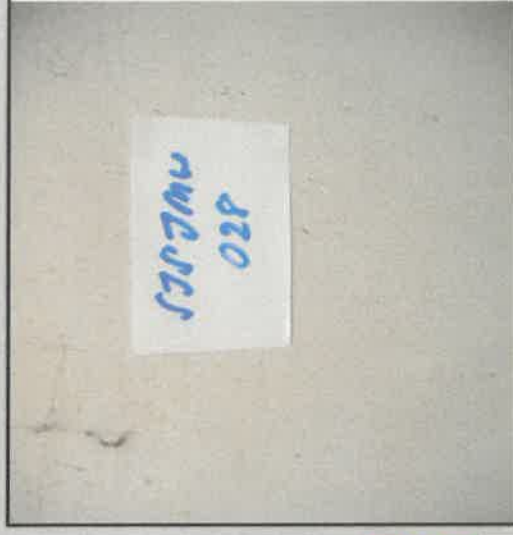
Site Photograph/Plan

Good condition

Amosite (Brown)

Material Assessment Score:

6

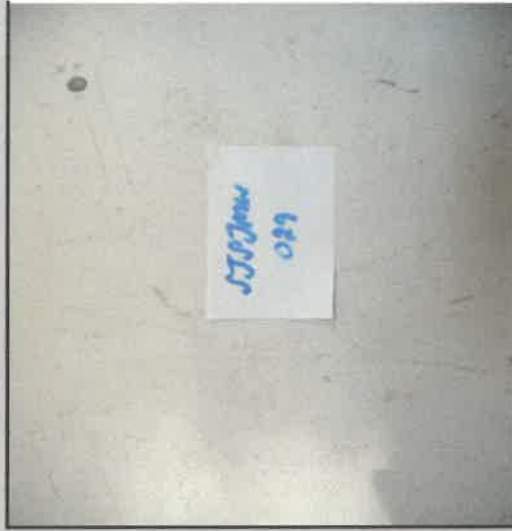
Site Photograph/Plan

Low Damage

Material Assessment Score:

7

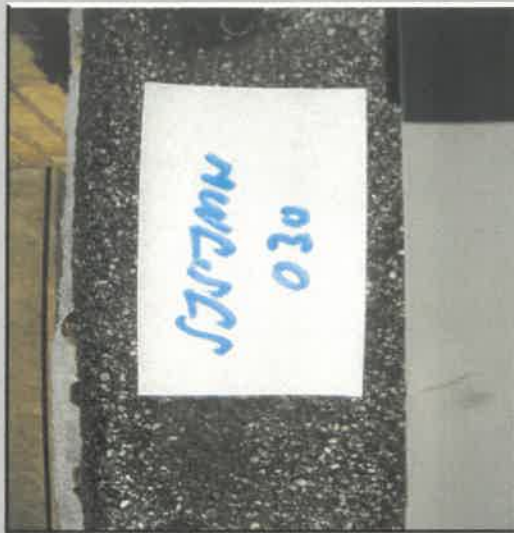
Site Photograph/Plan

Good condition

Material Assessment Score:

1
